## North West Hutton Decommissioning

6<sup>th</sup> February 2003

- The first stakeholder consultation on North West Hutton decommissioning took place in Aberdeen on 6<sup>th</sup> February 2003.
- A full report of the meeting is available on this website.

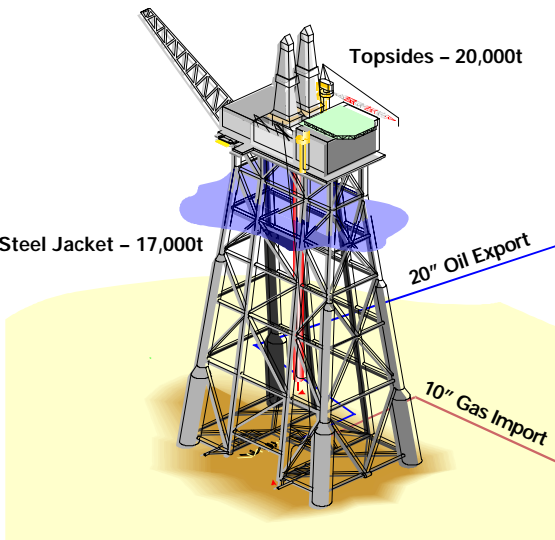
- Platform operational, no oil production
- Well decommissioning ongoing
- Topsides cleaning commencing
- Decommissioning team in-place
- Comparative assessment studies starting
- Stakeholder dialogue underway

- North West Hutton was discovered in 1975 and came into production in 1983.
- The field is 130km NE of the Shetland islands.

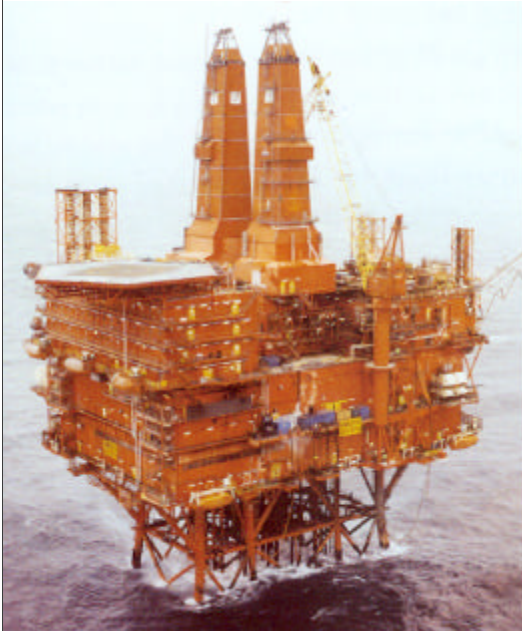
- Accommodation and support facilities for up to 210 personnel
- 2 Drilling rigs with 53 wells drilled from 40 well slots
- Power generation
- Water injection systems
- Capacity for 130,000 barrels per day of oil production
- Gas compression

- Total topsides weight is 20,000 tonnes.
- The topsides is made up of 22 modules each weighing between 500 and 2,500 tonnes.

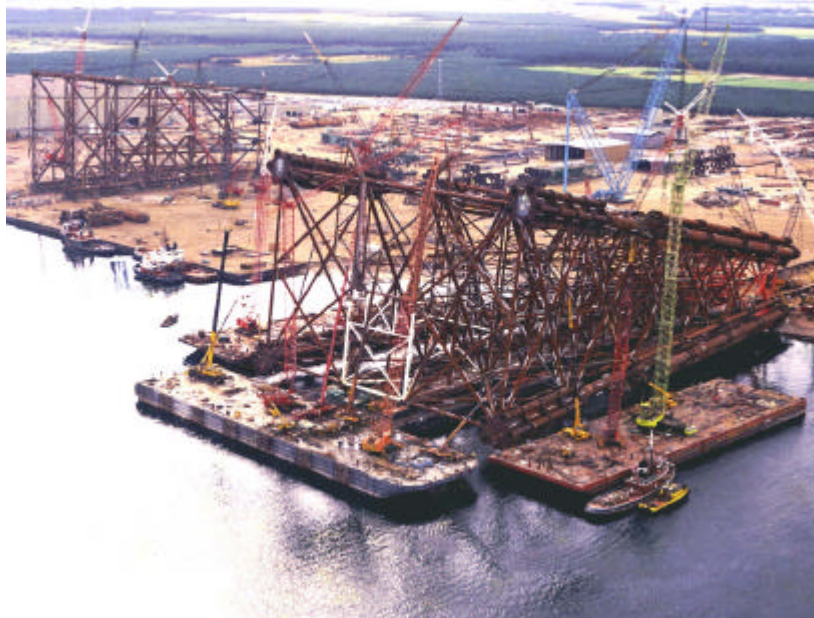
- The jacket weighs 17,000 tonnes and was built at Ardersier in the North of Scotland

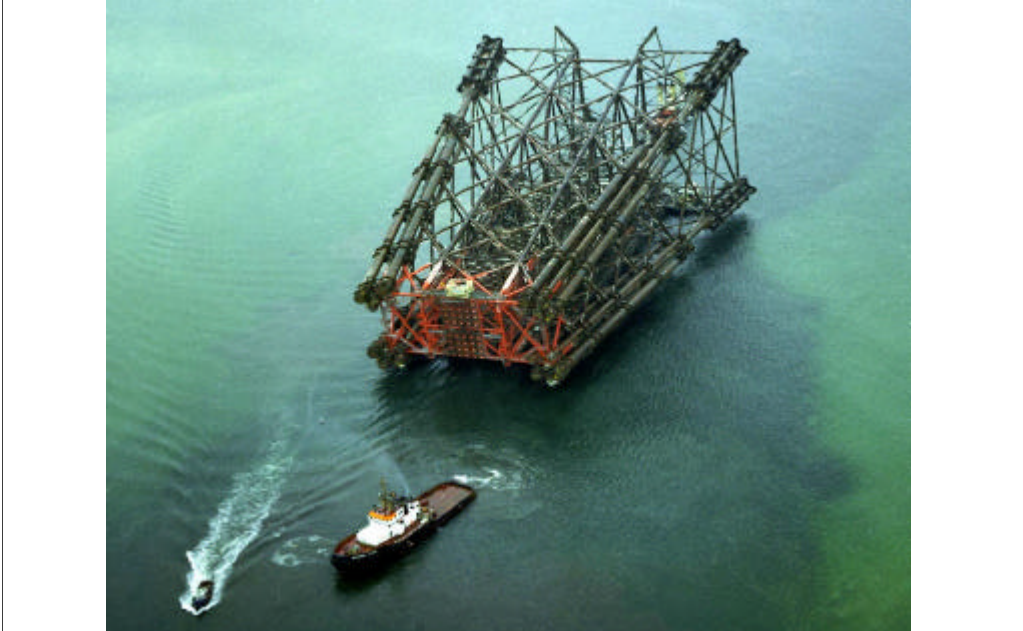
- The jacket was launched from the barge and fixed to the seabed by a total of 24 steel piles, each of 48 inch diameter

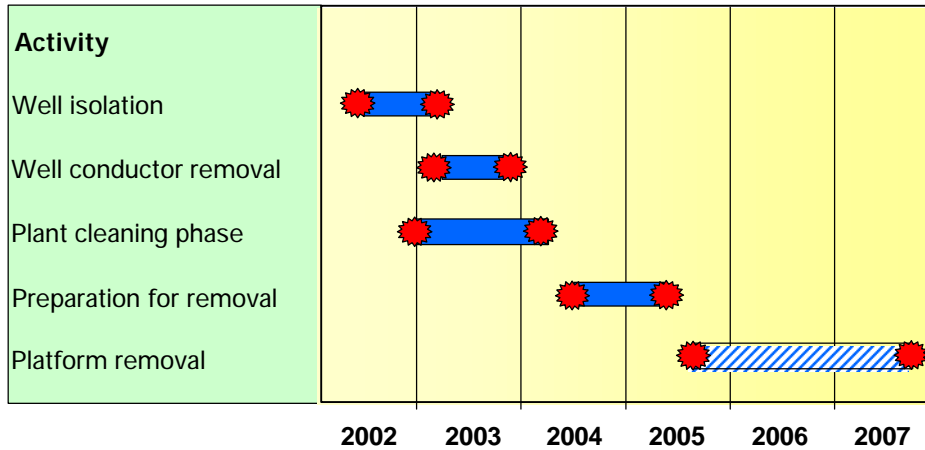
- The exact timing of platform removal can not be determined until other decisions have been made.
- We do not expect any major removal activity to start before 2005 at the earliest.
- The bar chart shows the possible window when removal might take place.
- This is likely to happen over a couple of 'seasons' as much of the activity is weather dependent.

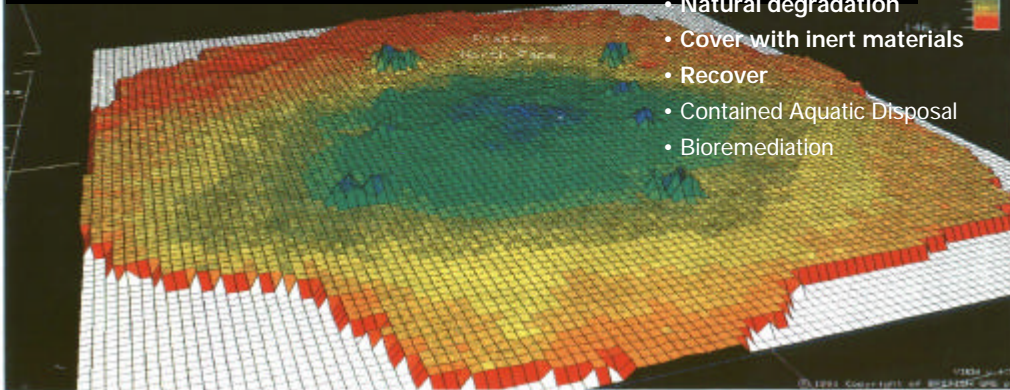
- This image of the NWH cuttings pile shows that the pile is mainly rock and water containing some oil and other components at trace levels.
- Environmental impact and options have been intensively studied by UKOOA including stakeholder consultation
- Five options identified. The last two - contained aquatic disposal and bioremediation - have been ruled out as not practical.

- Volume 25,000m<sup>3</sup> : 45% water; 48% rock; up to 7% oil and trace components
- Drill Cuttings Initiative
- Environmental Impact ?

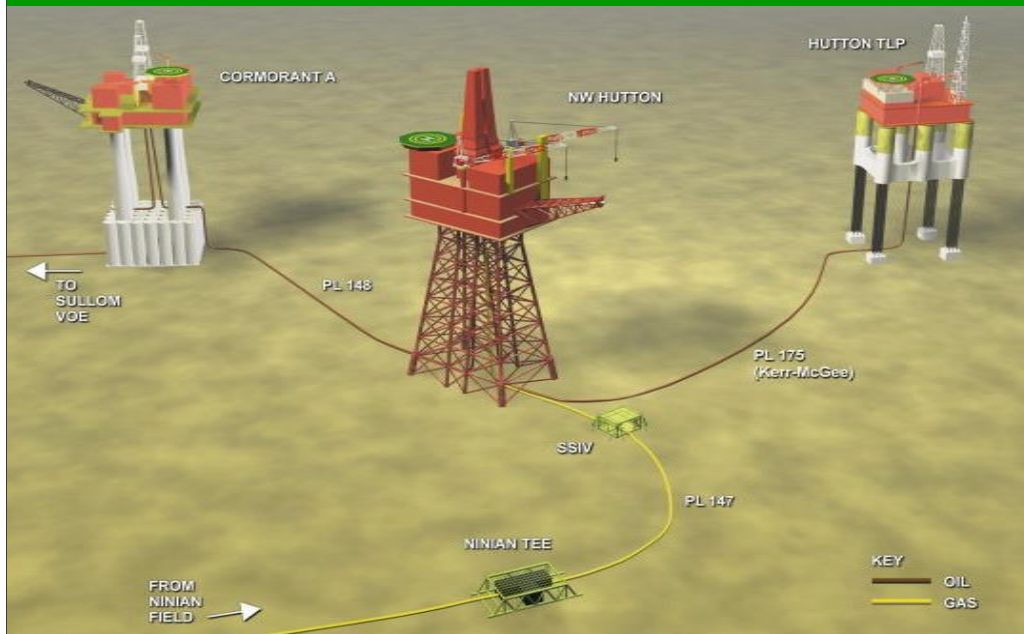
- The oil export line (PL 148) is 20 inch diameter with concrete coating and lies on the sea bed.
- This oil line runs from NWH to Cormorant A, a distance of around 10km.
- The gas line is 10 inch diameter and was trenched at the time of laying.
- This line runs between NWH and the Ninian field and BP is responsible for the first 12 km up to but not including the Ninian Tee.
- The SSIV (Sub Sea Isolation Valve) on the gas line will be removed as part of the decommissioning programme
- The Hutton TLP shown in the schematic has now been removed by the operator but the oil line has been left in place.
